Why Lockedair

Sound Performance Machine

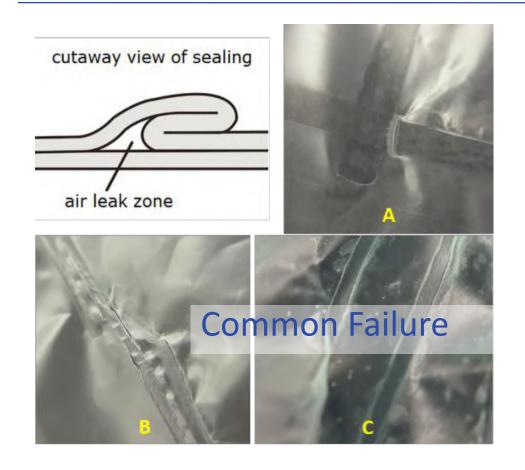
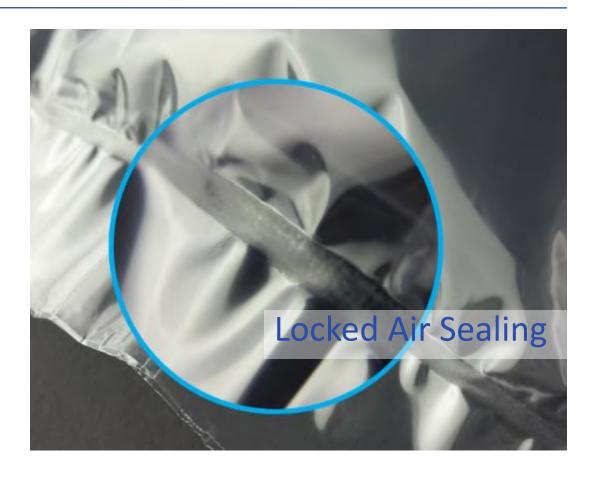
Lockedair's sealing line eliminated wrinkles, or leakage point by well controlled process including film tension, Pre-heat, heat Seal, Cooling down.

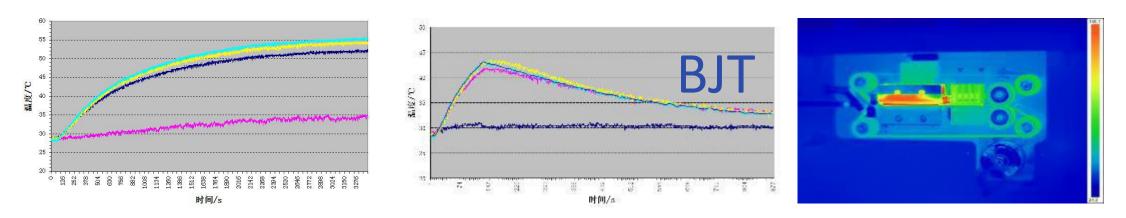
Adaptive Temp. Control

- -Dynamic compensation method to environment temperature
- -Positive control during different phase of machine operation
- -machine learning algorithm to adapt to temperature changes between the winter and summer.

Qualified air bag regardless of the environment temperature or phase of machine operation.

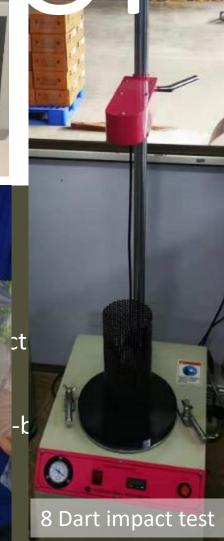
- Vision check
- 1) Moderate compression strength (Tensile Strength = 93.4 Mpa)
- 2 Super resilience. (Punture Force= 103N/mm)
- (3) High resistance to puncture. (Dart Drop Impact= 350g)
- 4 Stability under the extreme pressure (Tear Strenth = 64.5N, Tensile Elongation = 750%)
